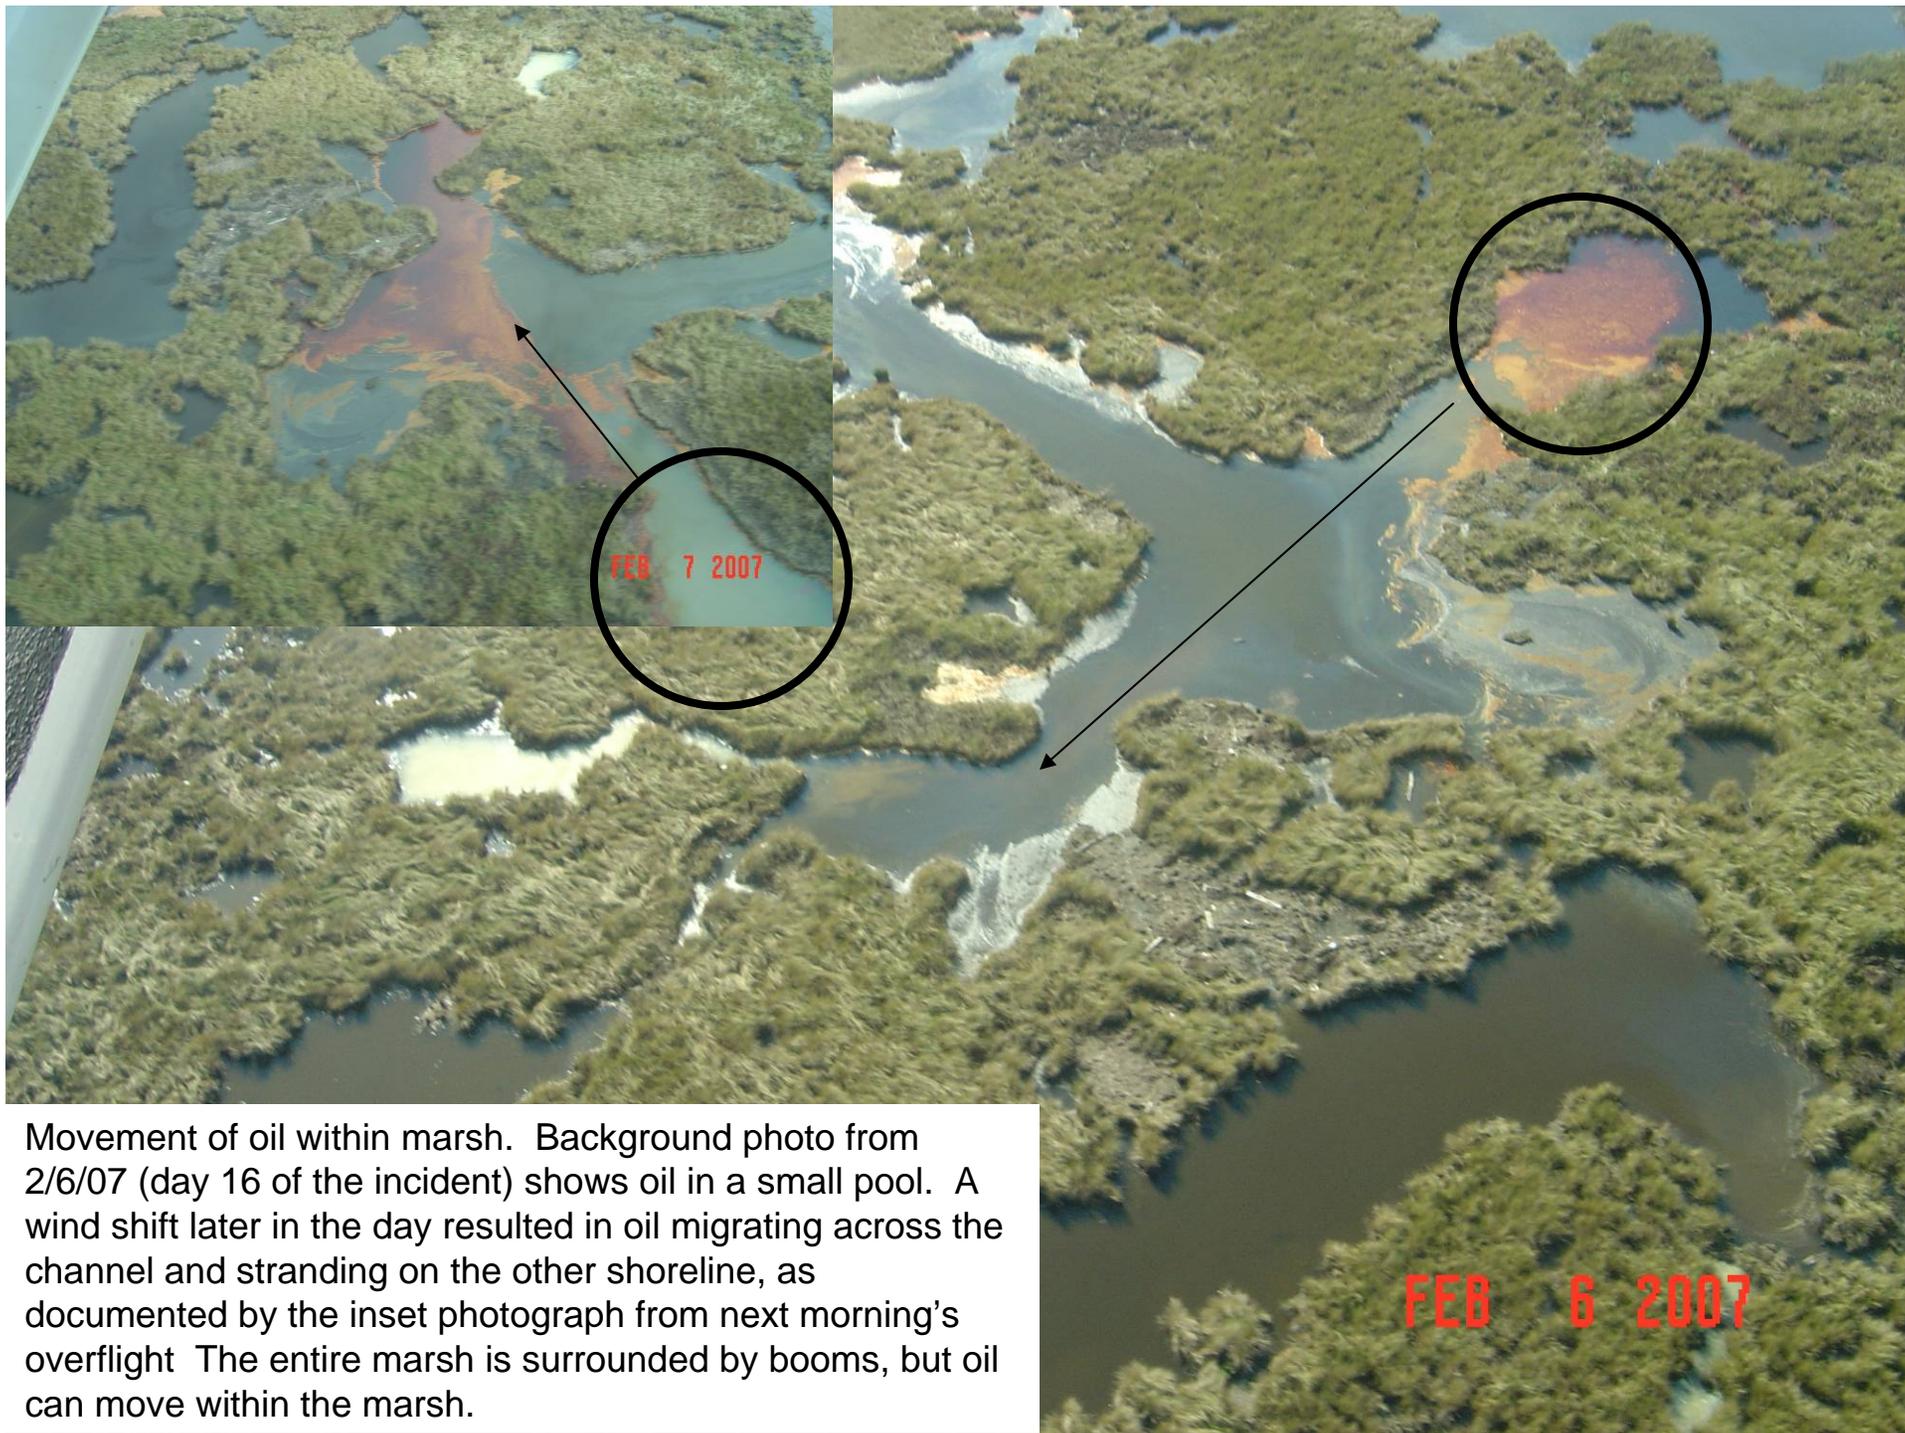
Movement of oil within marsh. Background photo from 2/6/07 (day 16 of the incident) shows oil in a small pool. A wind shift later in the day resulted in oil migrating across the channel and stranding on the other shoreline, as documented by the inset photograph from next morning's overflight. The entire marsh is surrounded by booms, but oil can move within the marsh.
